**PHASE ONE ENVIRONMENTAL SITE ASSESSMENT  
294 QUAKER ROAD  
WELLAND, ONTARIO**

**CENTENNIAL HOMES (NIAGARA) INC.**

**SOIL-MAT ENGINEERS & CONSULTANTS LTD.  
401 GRAYS ROAD  
HAMILTON, ONTARIO  
L8E 2Z3**

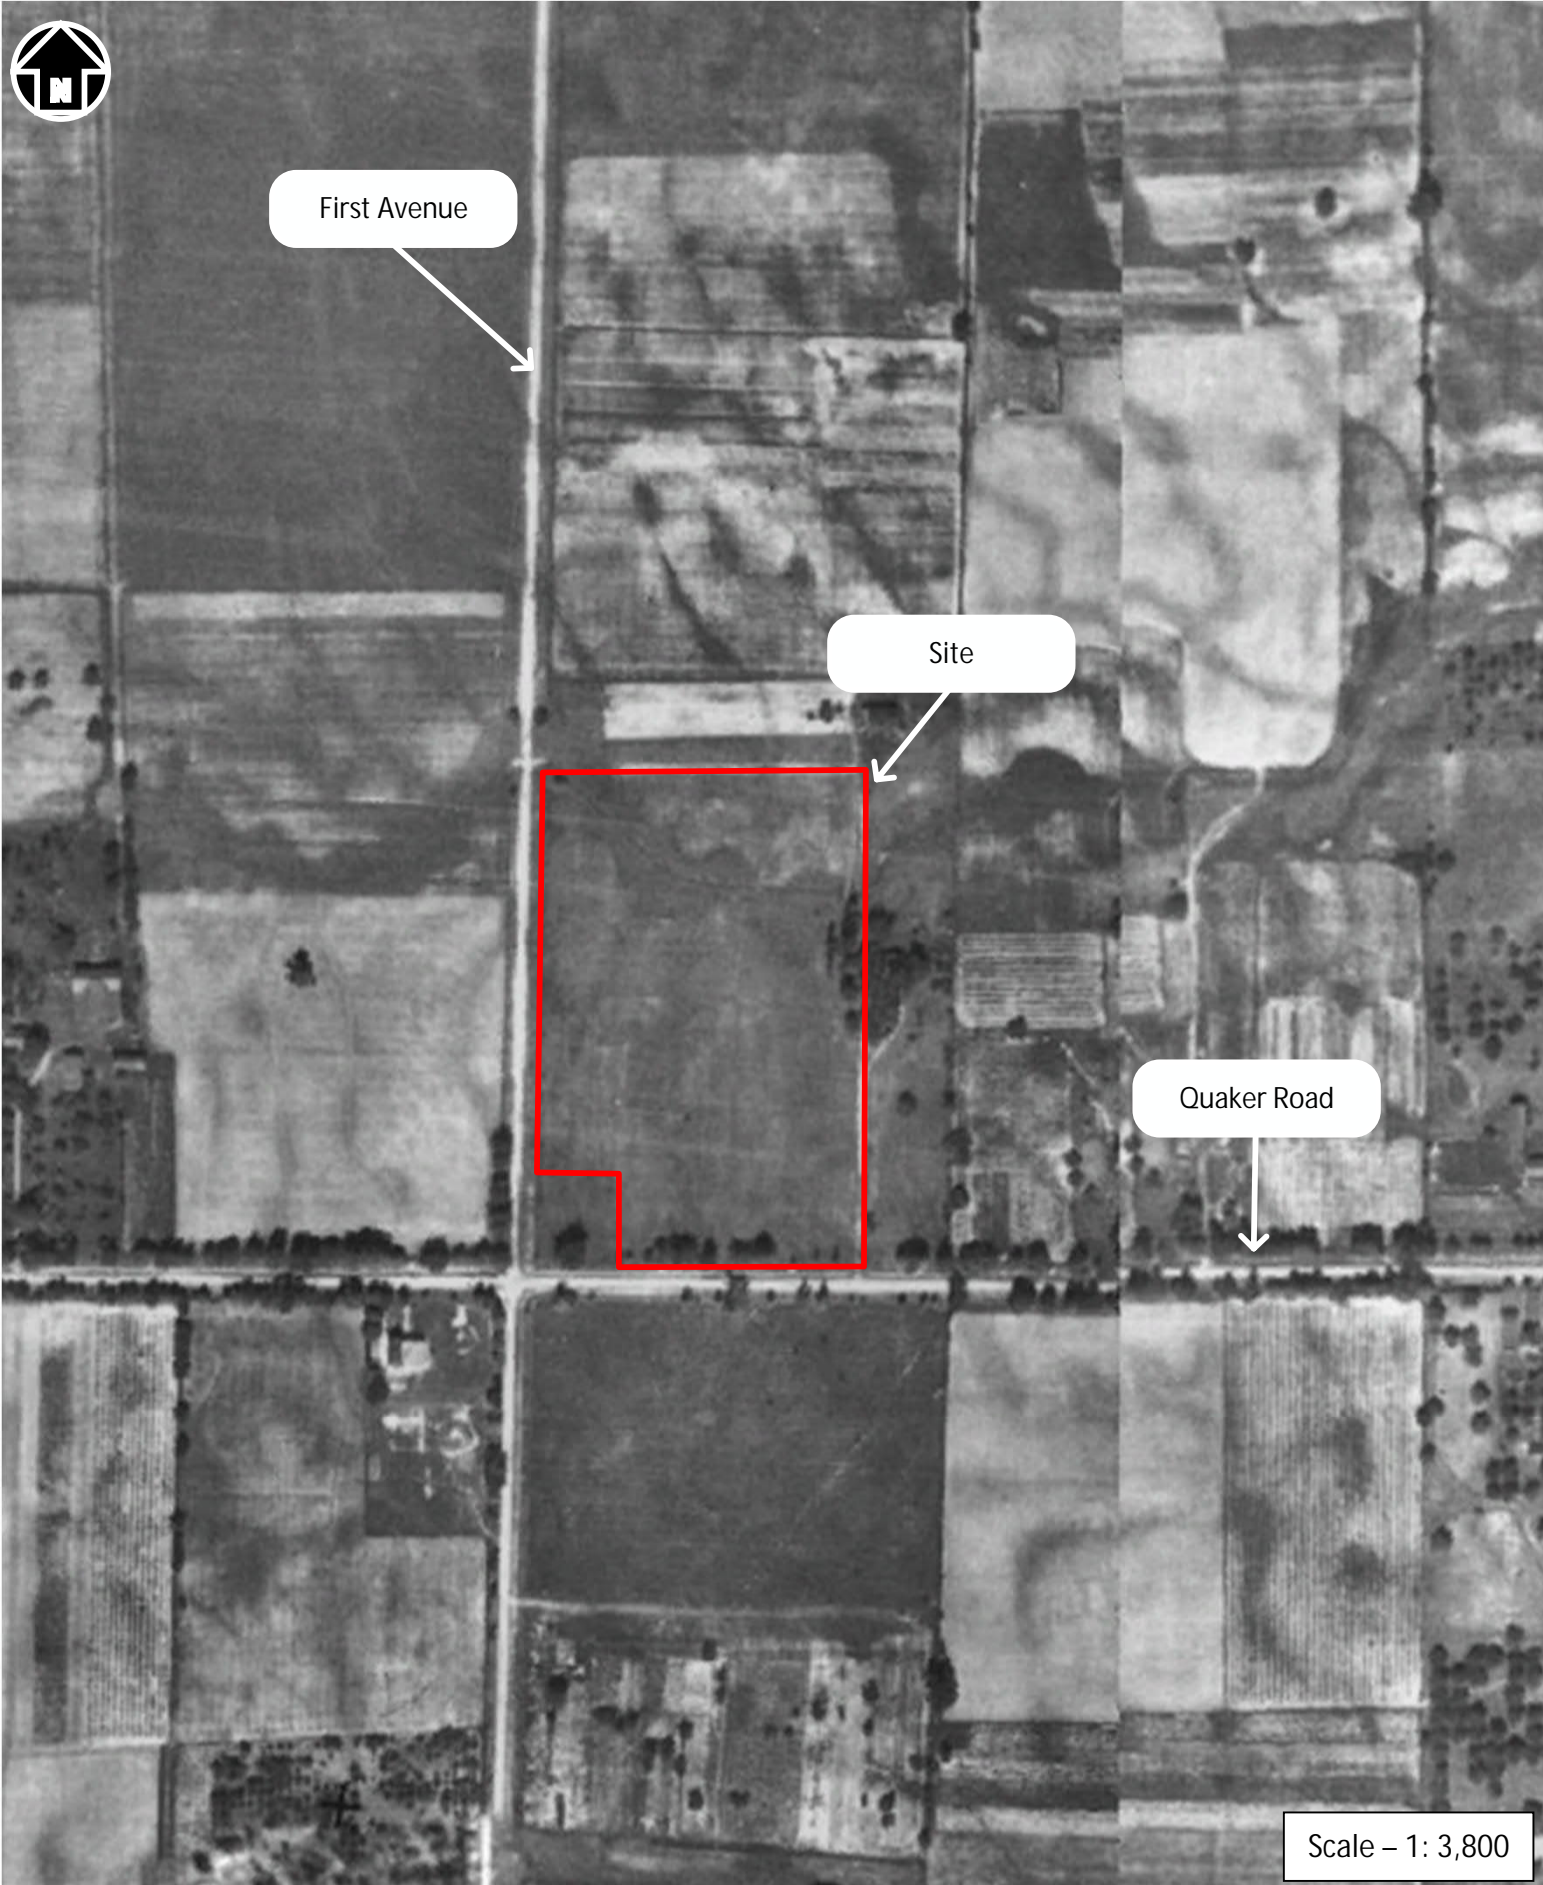
Aerial Photo – 1965

The historical agricultural use on the Site is considered a PCA that may cause an APEC on the Site. However, it is the opinion of SOIL-MAT ENGINEERS that an adverse environmental impact originating from the former agricultural lands is not considered a significant environmental concern at this time, provided;
