**PHASE 2 ESA CONCEPTUAL SITE MODEL**

**210 QUAKER ROAD, WELLAND, ON**

Project: E-16-26-2

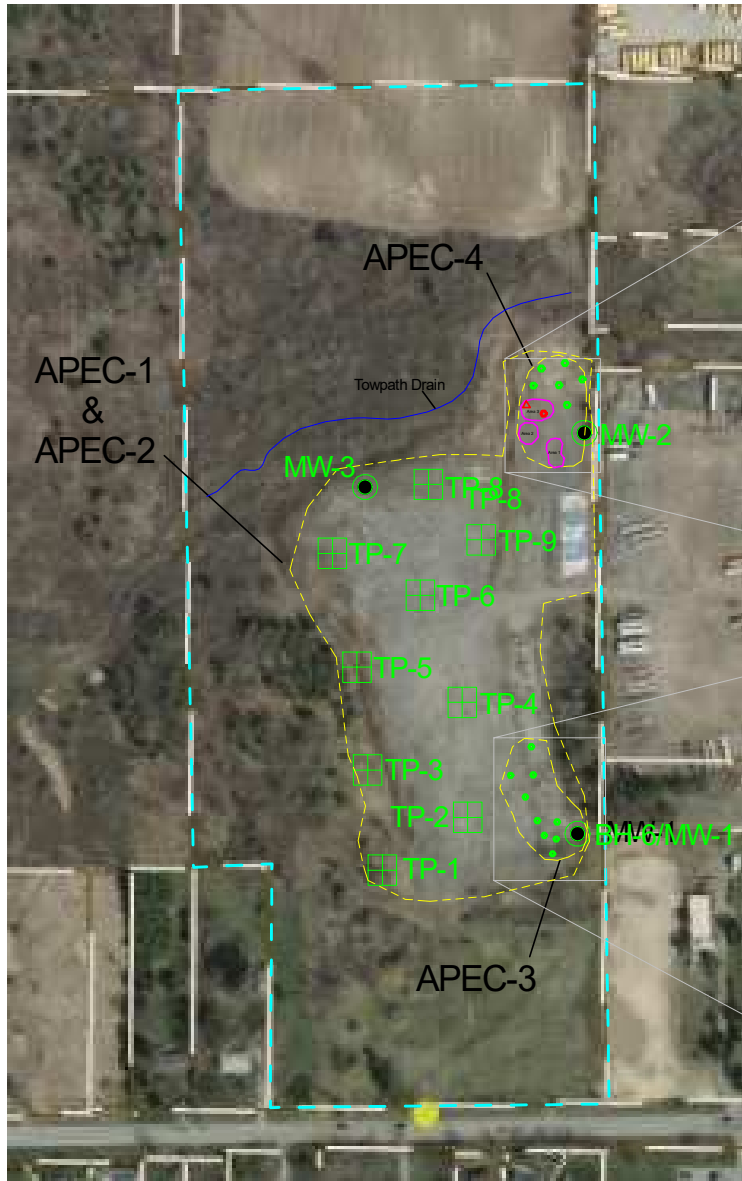
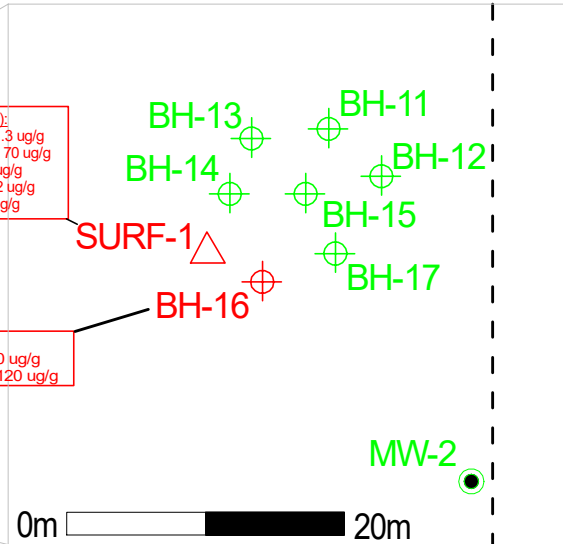
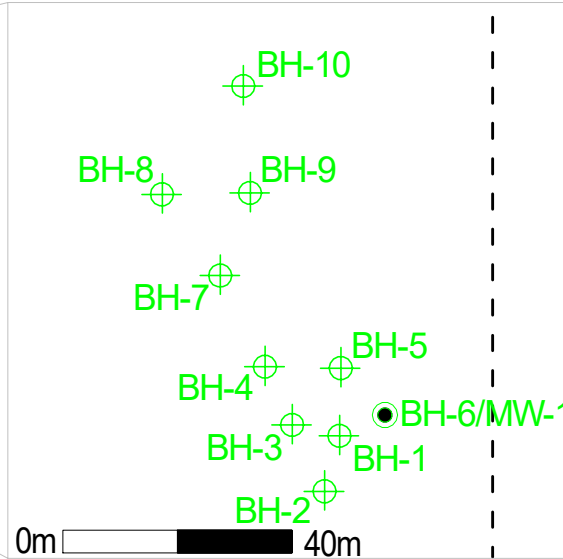
Soil results from test-pits and borehole sample locations pertaining to APEC-1, APEC-2 and APEC-3 all met applicable MOE Table 9 criteria with no exceedances noted. Soil results from the borehole investigation within APEC-4 revealed exceedances at borehole sample location BH-16 for PHC F2 and F4 and at SURF-1 for Metals as presented below and on Figure 3c.

**SURF-1 (0-0.051 mbgs):**  
 Antimony 7.8 ug/g vs. 1.3 ug/g  
 Chromium 187 ug/g vs. 70 ug/g  
 Cobalt 338 ug/g vs. 22 ug/g  
 Copper 1190 ug/g vs. 92 ug/g  
 Nickel 992 ug/g vs. 82 ug/g

**BH-16 (0-0.10 mbgs):**  
 PHC F2 16 ug/g vs. 10 ug/g  
 PHC F4 130 ug/g vs. 120 ug/g

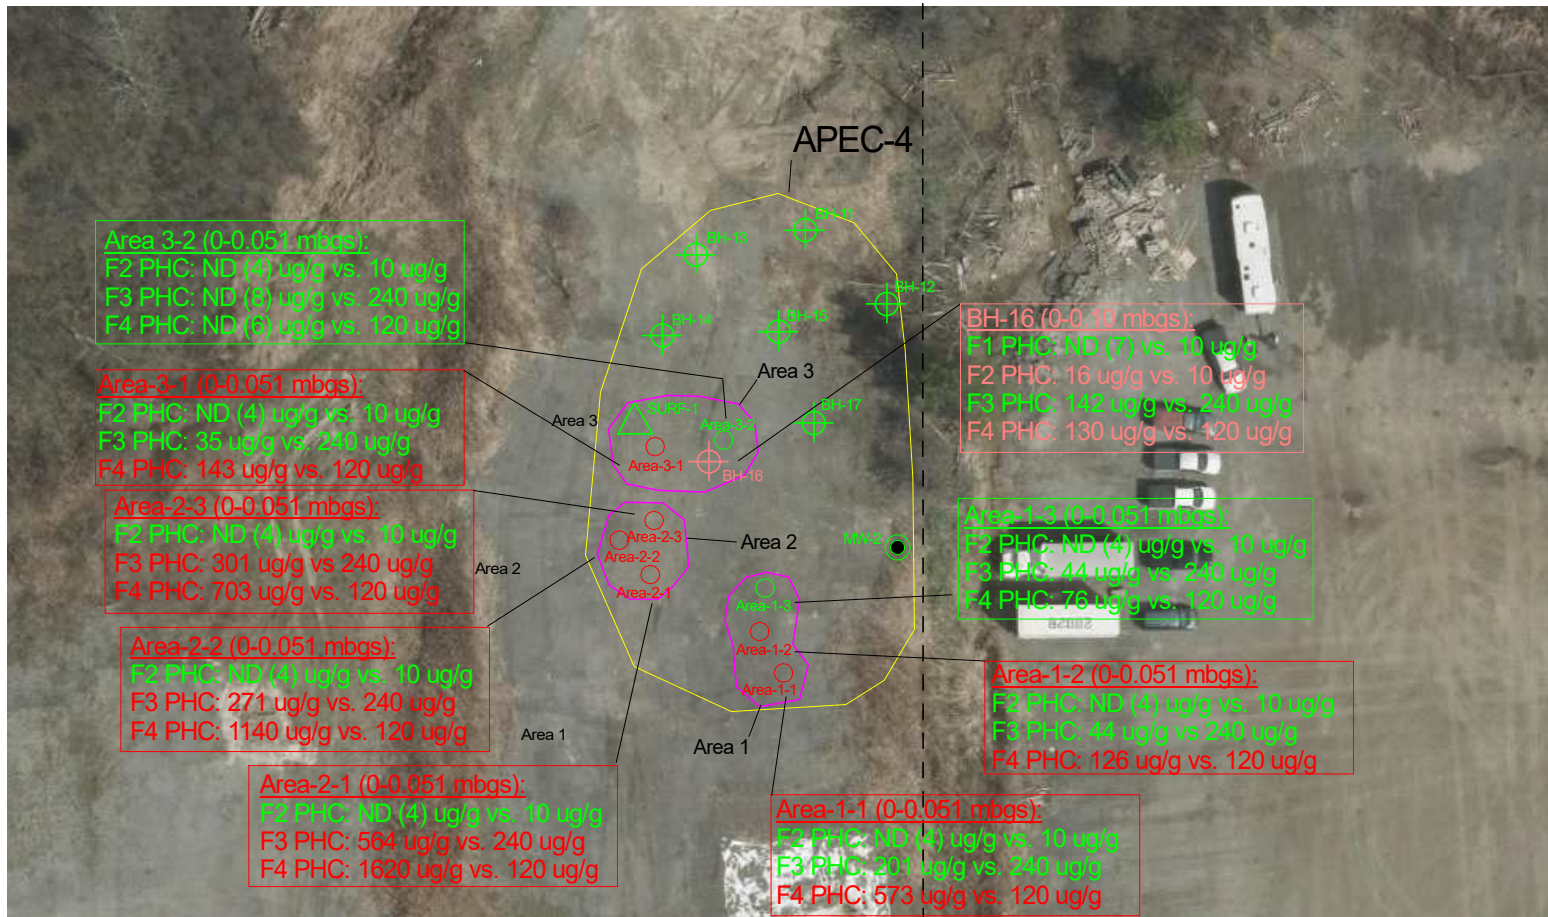
| September 2017 | <b>6a</b> |

Note: Areas 1, 2, 3 were individually identified within APEC-4 due to visible evidence of fill material and staining. See Section 8.2 in CSM Report for additional explanation.

Within the area designated as APEC-4 two distinct pockets of black foundry sand and one area that was questionable for containing foundry sand was identified. The areas were labelled as Area 1, Area 2 and Area 3. Area 3 (the questionable black foundry sand area) was the only one initially sampled (with results BH-16 and SURF-1 reported above). Initial excavation of Areas 1 and 2 with subsequent verification sampling was planned based on visual inspection and previous Phase Two work at the site. A Toxicity Characteristic Leachate Procedure (TCLP) analysis was conducted on the fill material for landfill disposal requirements. Anthony's Excavating Inc. was subcontracted to remove the contaminated material from Areas 1, 2 and 3 via scrapping layers of soil. The material was disposed of at Walker's Landfill. Initial verification and sampling was obtained from the floor area of the excavation as maximum depth was 2" (0.051m). Laboratory results continued to revealed exceedances for Metals and PHCs F3 and F4 as presented below and on excavation Figures 6a-6e and cross section Figures 7a and 7b.

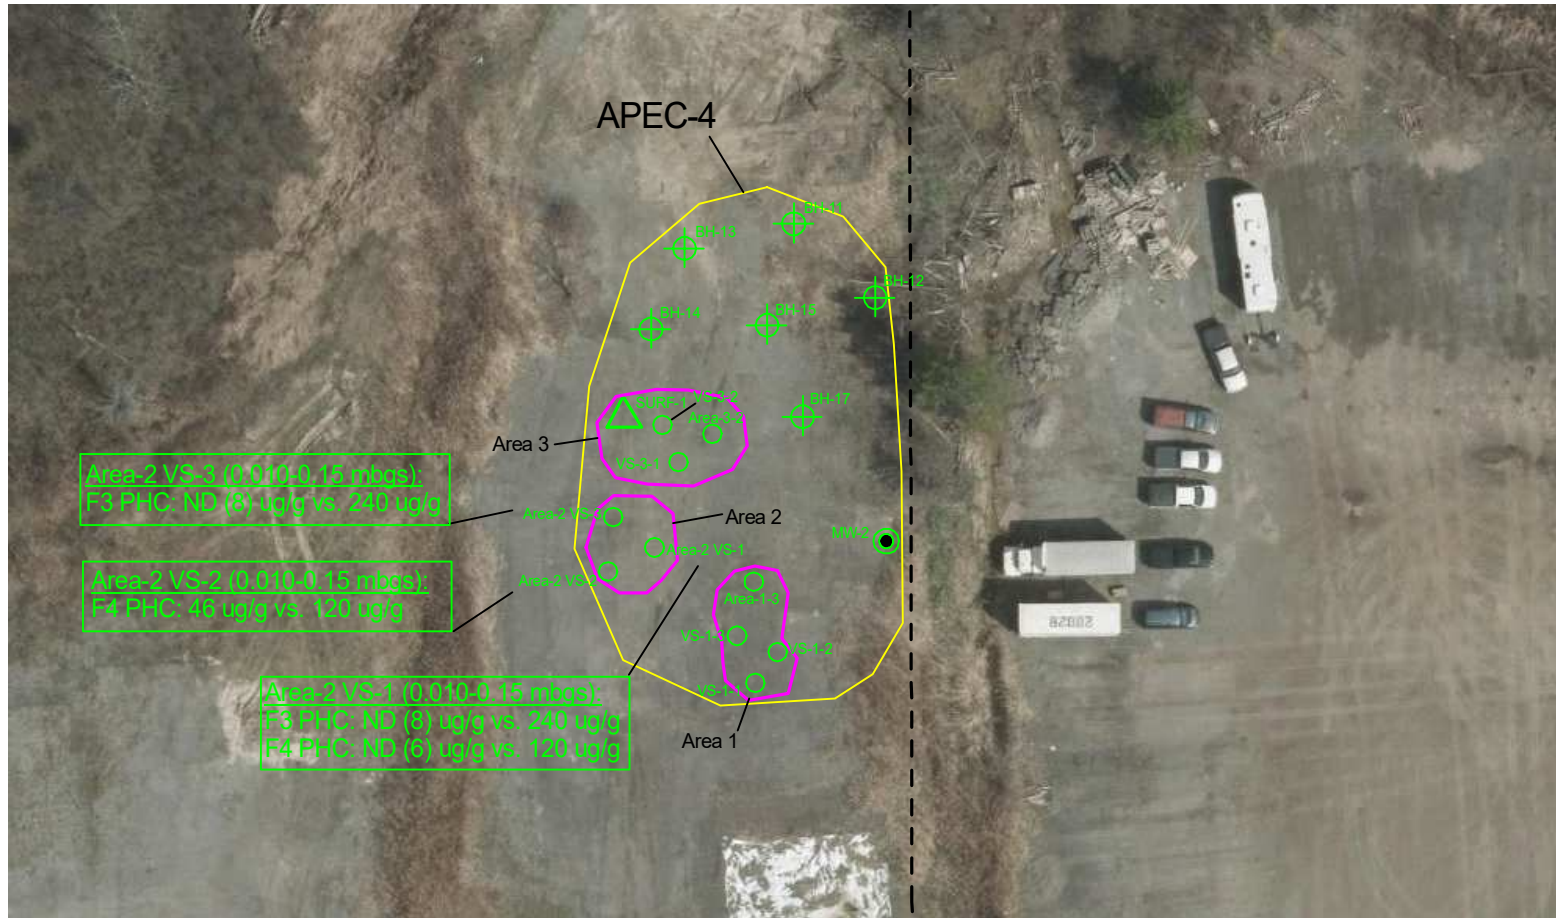
Source: 2016 Google Earth Imagery

Note: Areas 1, 2, 3 were individually identified within APEC-4 due to visible evidence of fill material and staining. See Section 8.2 in CSM Report for additional explanation.

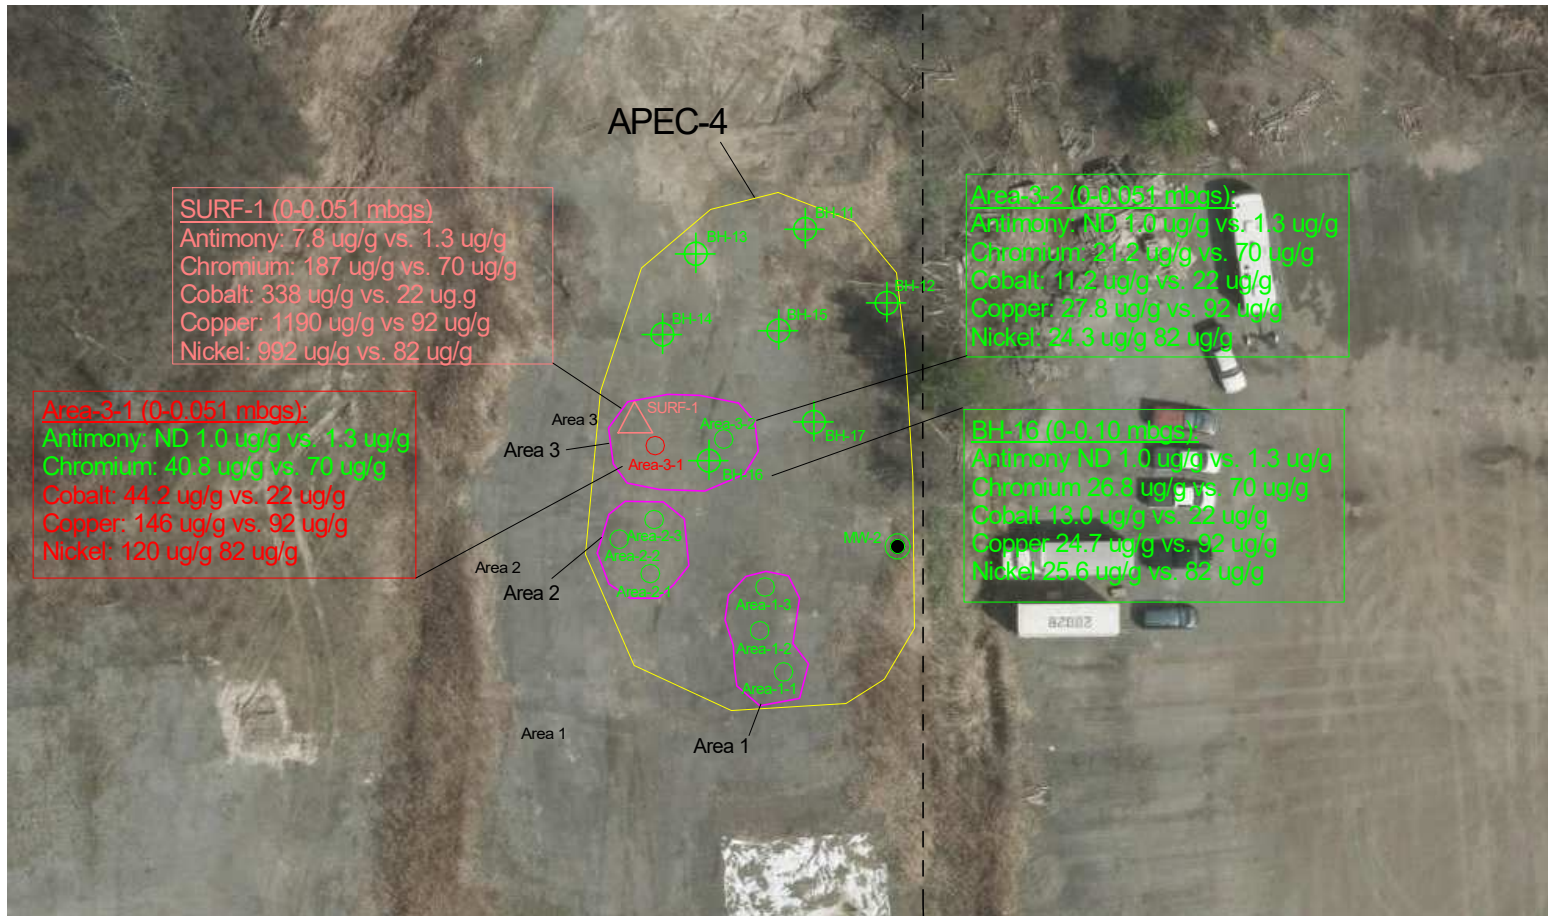
| September 2017 | <b>6d</b> |

Note: Areas 1, 2, 3 were individually identified within APEC-4 due to visible evidence of fill material and staining. See Section 8.2 in CSM Report for additional explanation.

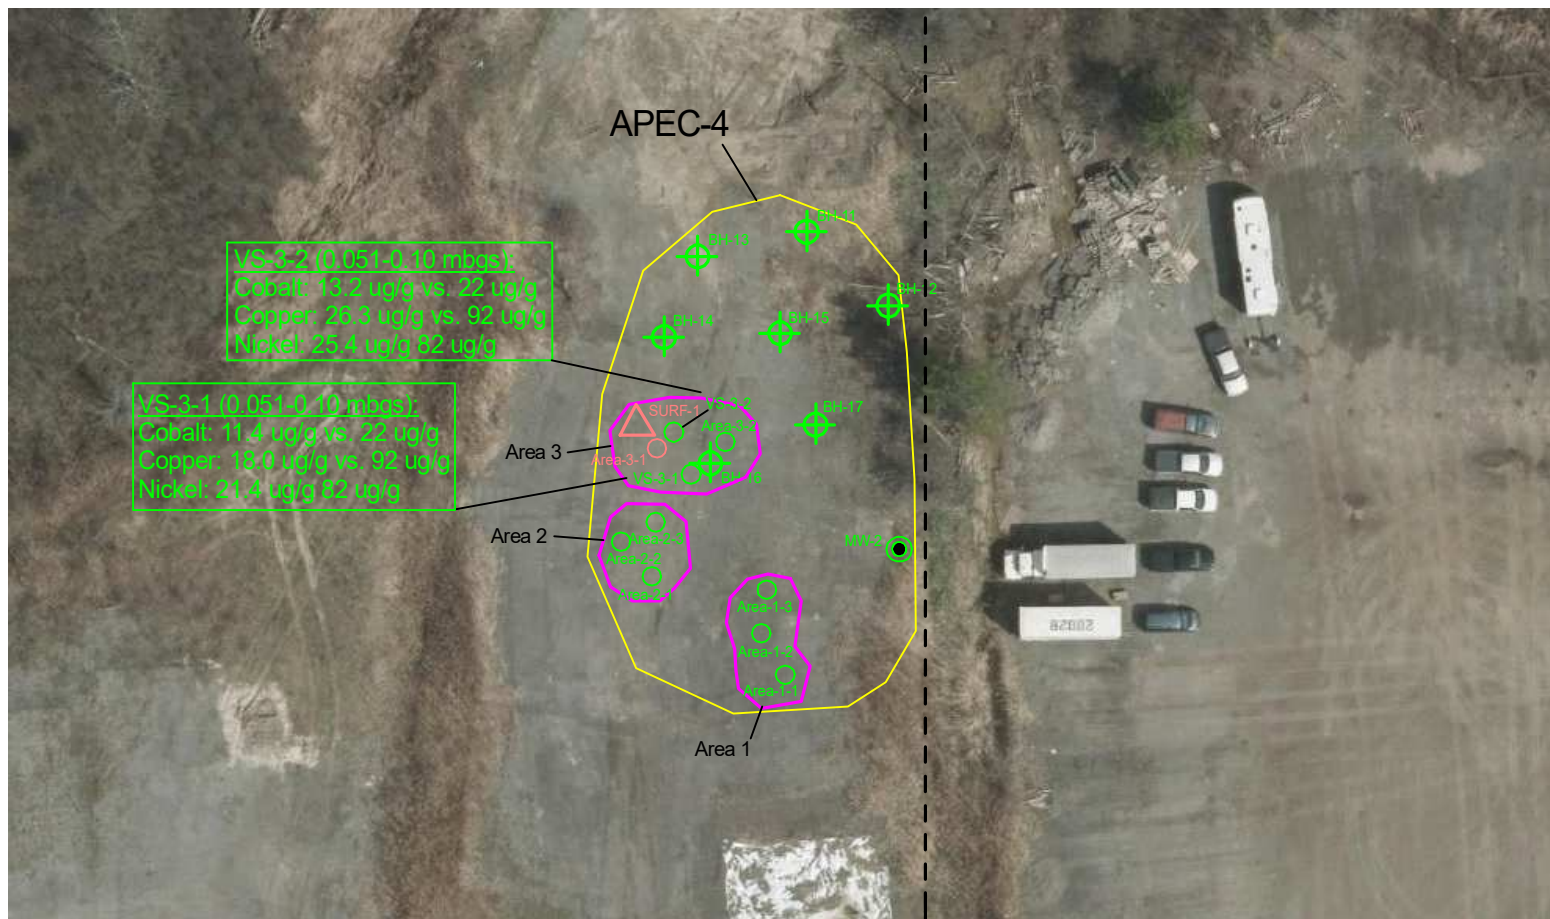
Source: 2016 Google Earth Imagery

Note: Areas 1, 2, 3 were individually identified within APEC-4 due to visible evidence of fill material and staining. See Section 8.2 in CSM Report for additional explanation.

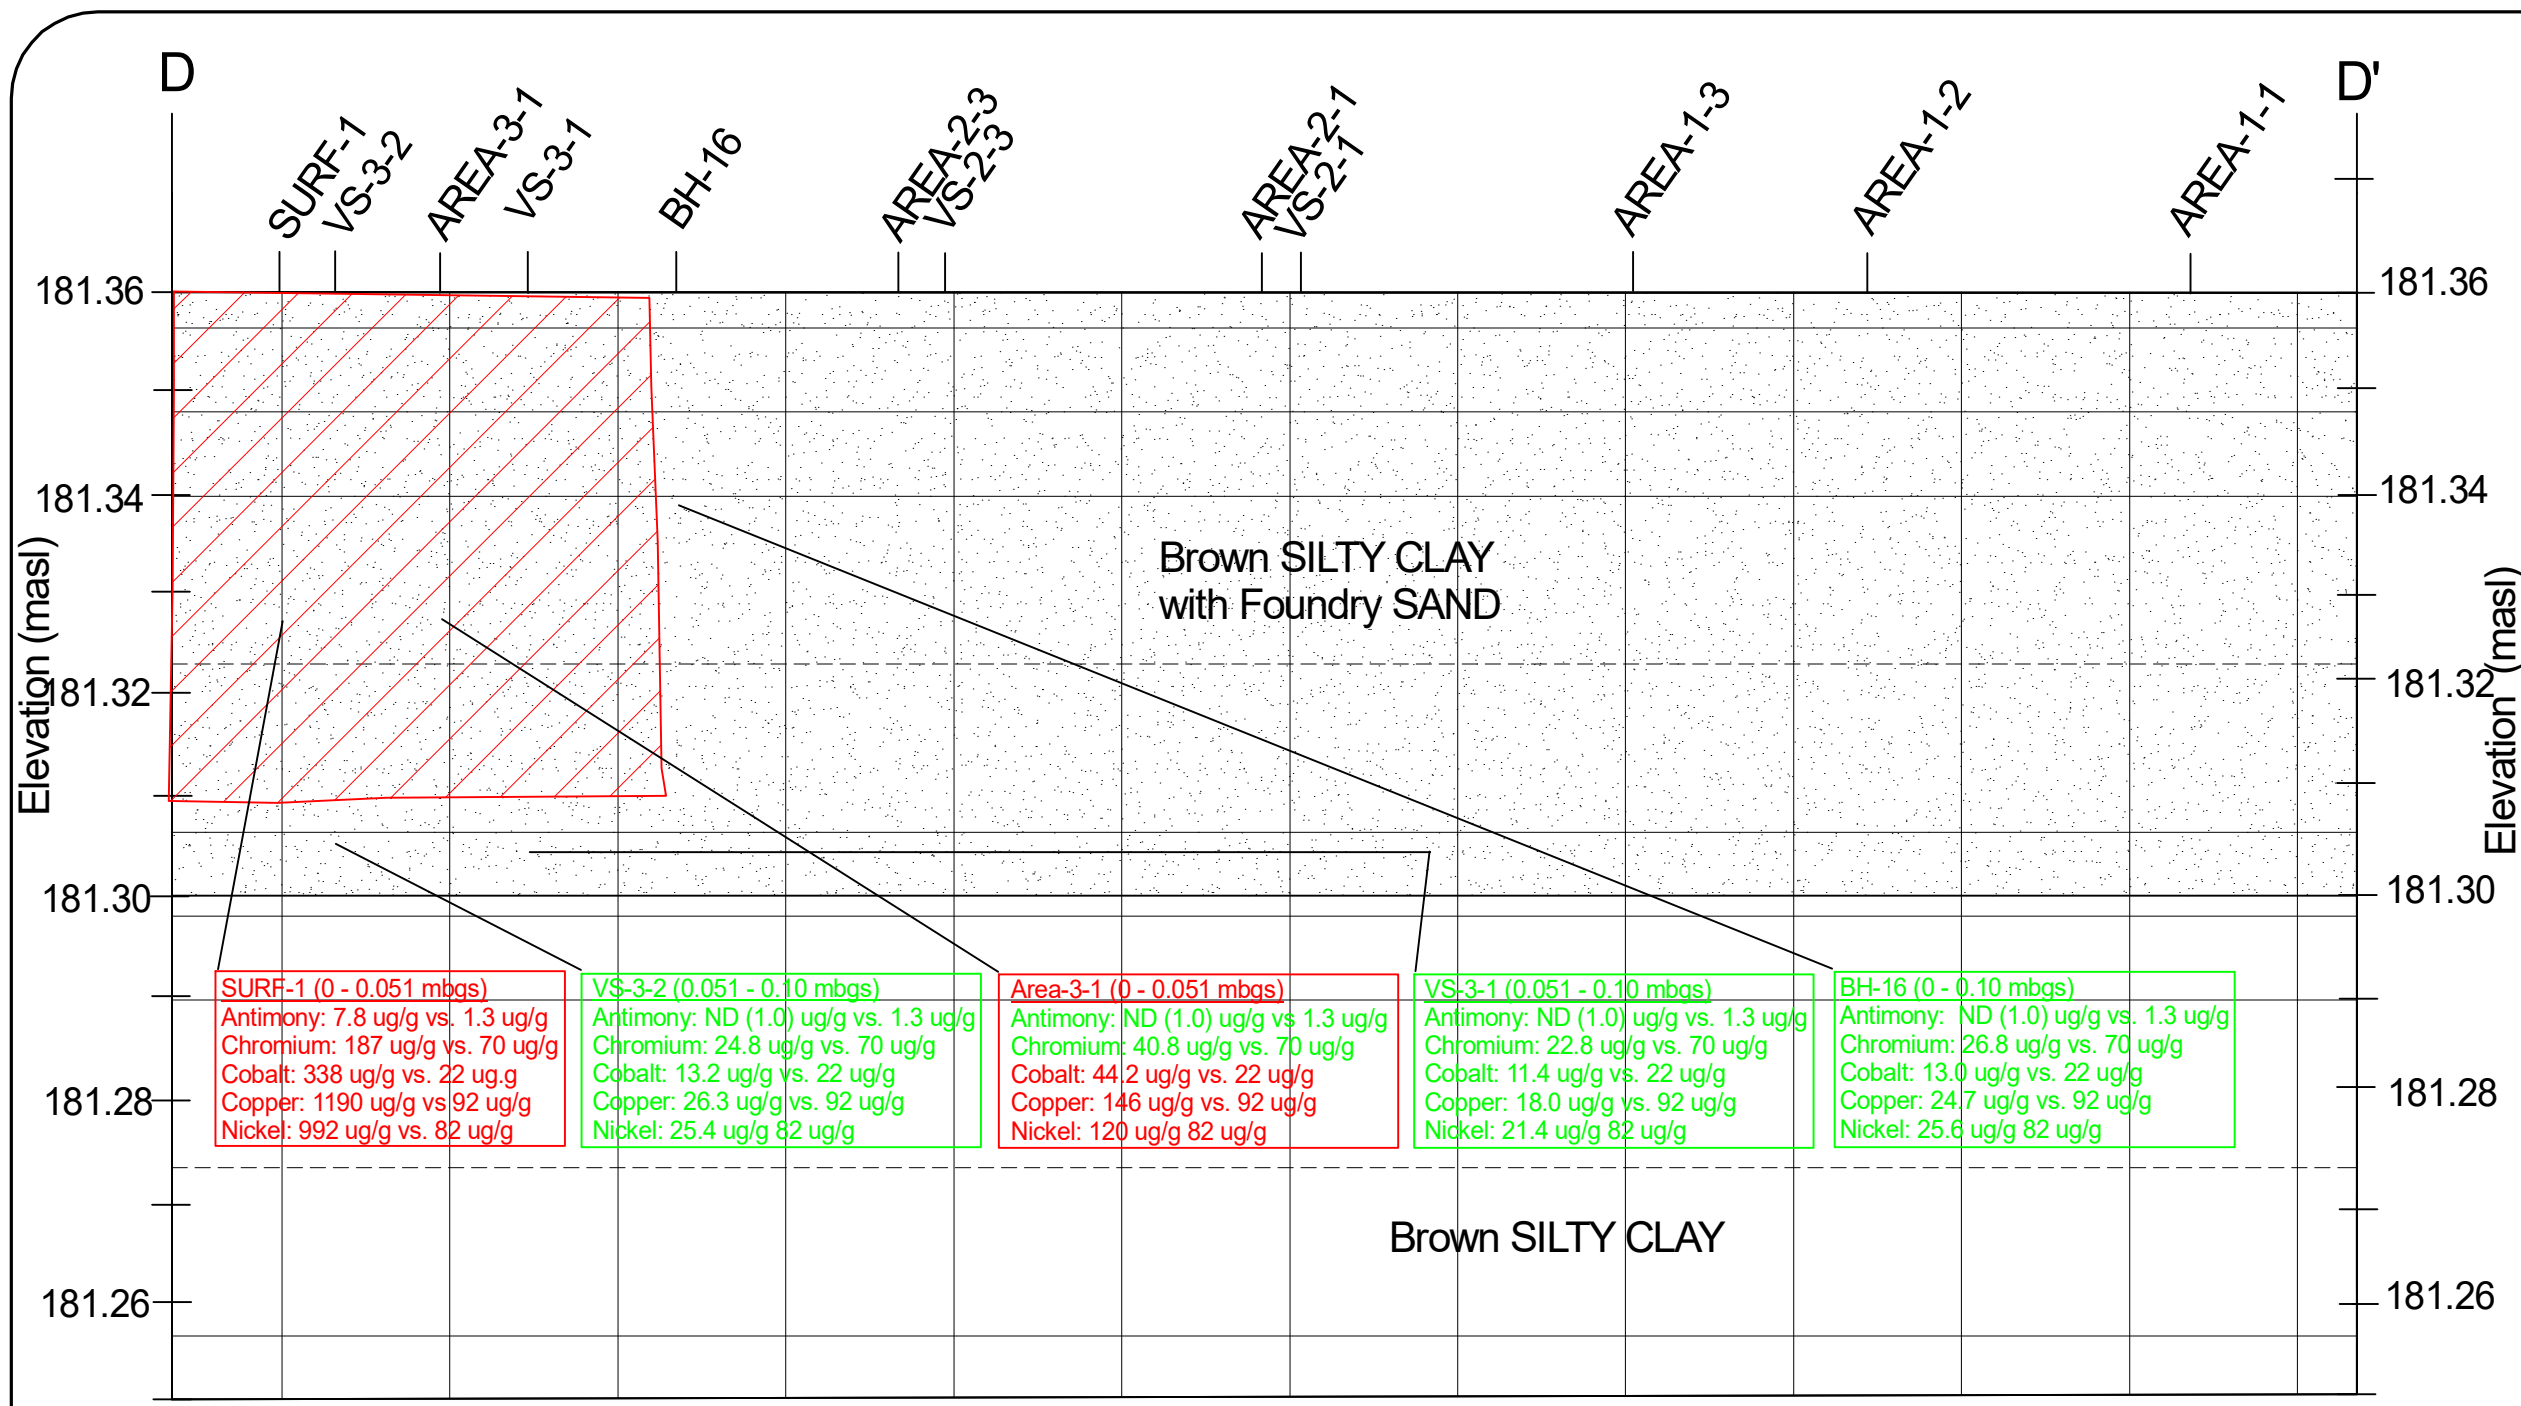
| DATE:<br>September 2017 | <b>7a</b> |

**SURF-1 (0 - 0.051 mbgs)**  
 Antimony: 7.8 ug/g vs. 1.3 ug/g  
 Chromium: 187 ug/g vs. 70 ug/g  
 Cobalt: 338 ug/g vs. 22 ug/g  
 Copper: 1190 ug/g vs. 92 ug/g  
 Nickel: 992 ug/g vs. 82 ug/g

**VS-3-2 (0.051 - 0.10 mbgs)**  
 Antimony: ND (1.0) ug/g vs. 1.3 ug/g  
 Chromium: 24.8 ug/g vs. 70 ug/g  
 Cobalt: 13.2 ug/g vs. 22 ug/g  
 Copper: 26.3 ug/g vs. 92 ug/g  
 Nickel: 25.4 ug/g vs. 82 ug/g

**VS-3-1 (0.051 - 0.10 mbgs)**  
 Antimony: ND (1.0) ug/g vs. 1.3 ug/g  
 Chromium: 22.8 ug/g vs. 70 ug/g  
 Cobalt: 11.4 ug/g vs. 22 ug/g  
 Copper: 18.0 ug/g vs. 92 ug/g  
 Nickel: 21.4 ug/g vs. 82 ug/g

**BH-16 (0 - 0.10 mbgs)**  
 Antimony: ND (1.0) ug/g vs. 1.3 ug/g  
 Chromium: 26.8 ug/g vs. 70 ug/g  
 Cobalt: 13.0 ug/g vs. 22 ug/g  
 Copper: 24.7 ug/g vs. 92 ug/g  
 Nickel: 25.6 ug/g vs. 82 ug/g

The extent of exceedances noted within APEC-4 appeared to only coincide with the locations of the black foundry slag material potentially deposited as fill to grade the site for parking lot use. Over time, target contaminants from the parking lot area were deposited to the sediment within Towpath Drain. Horizontal migration of contaminants was observed at the site via runoff from the parking areas. Vertical migration of contaminants was not observed throughout the site as was confirmed through clean sample results.

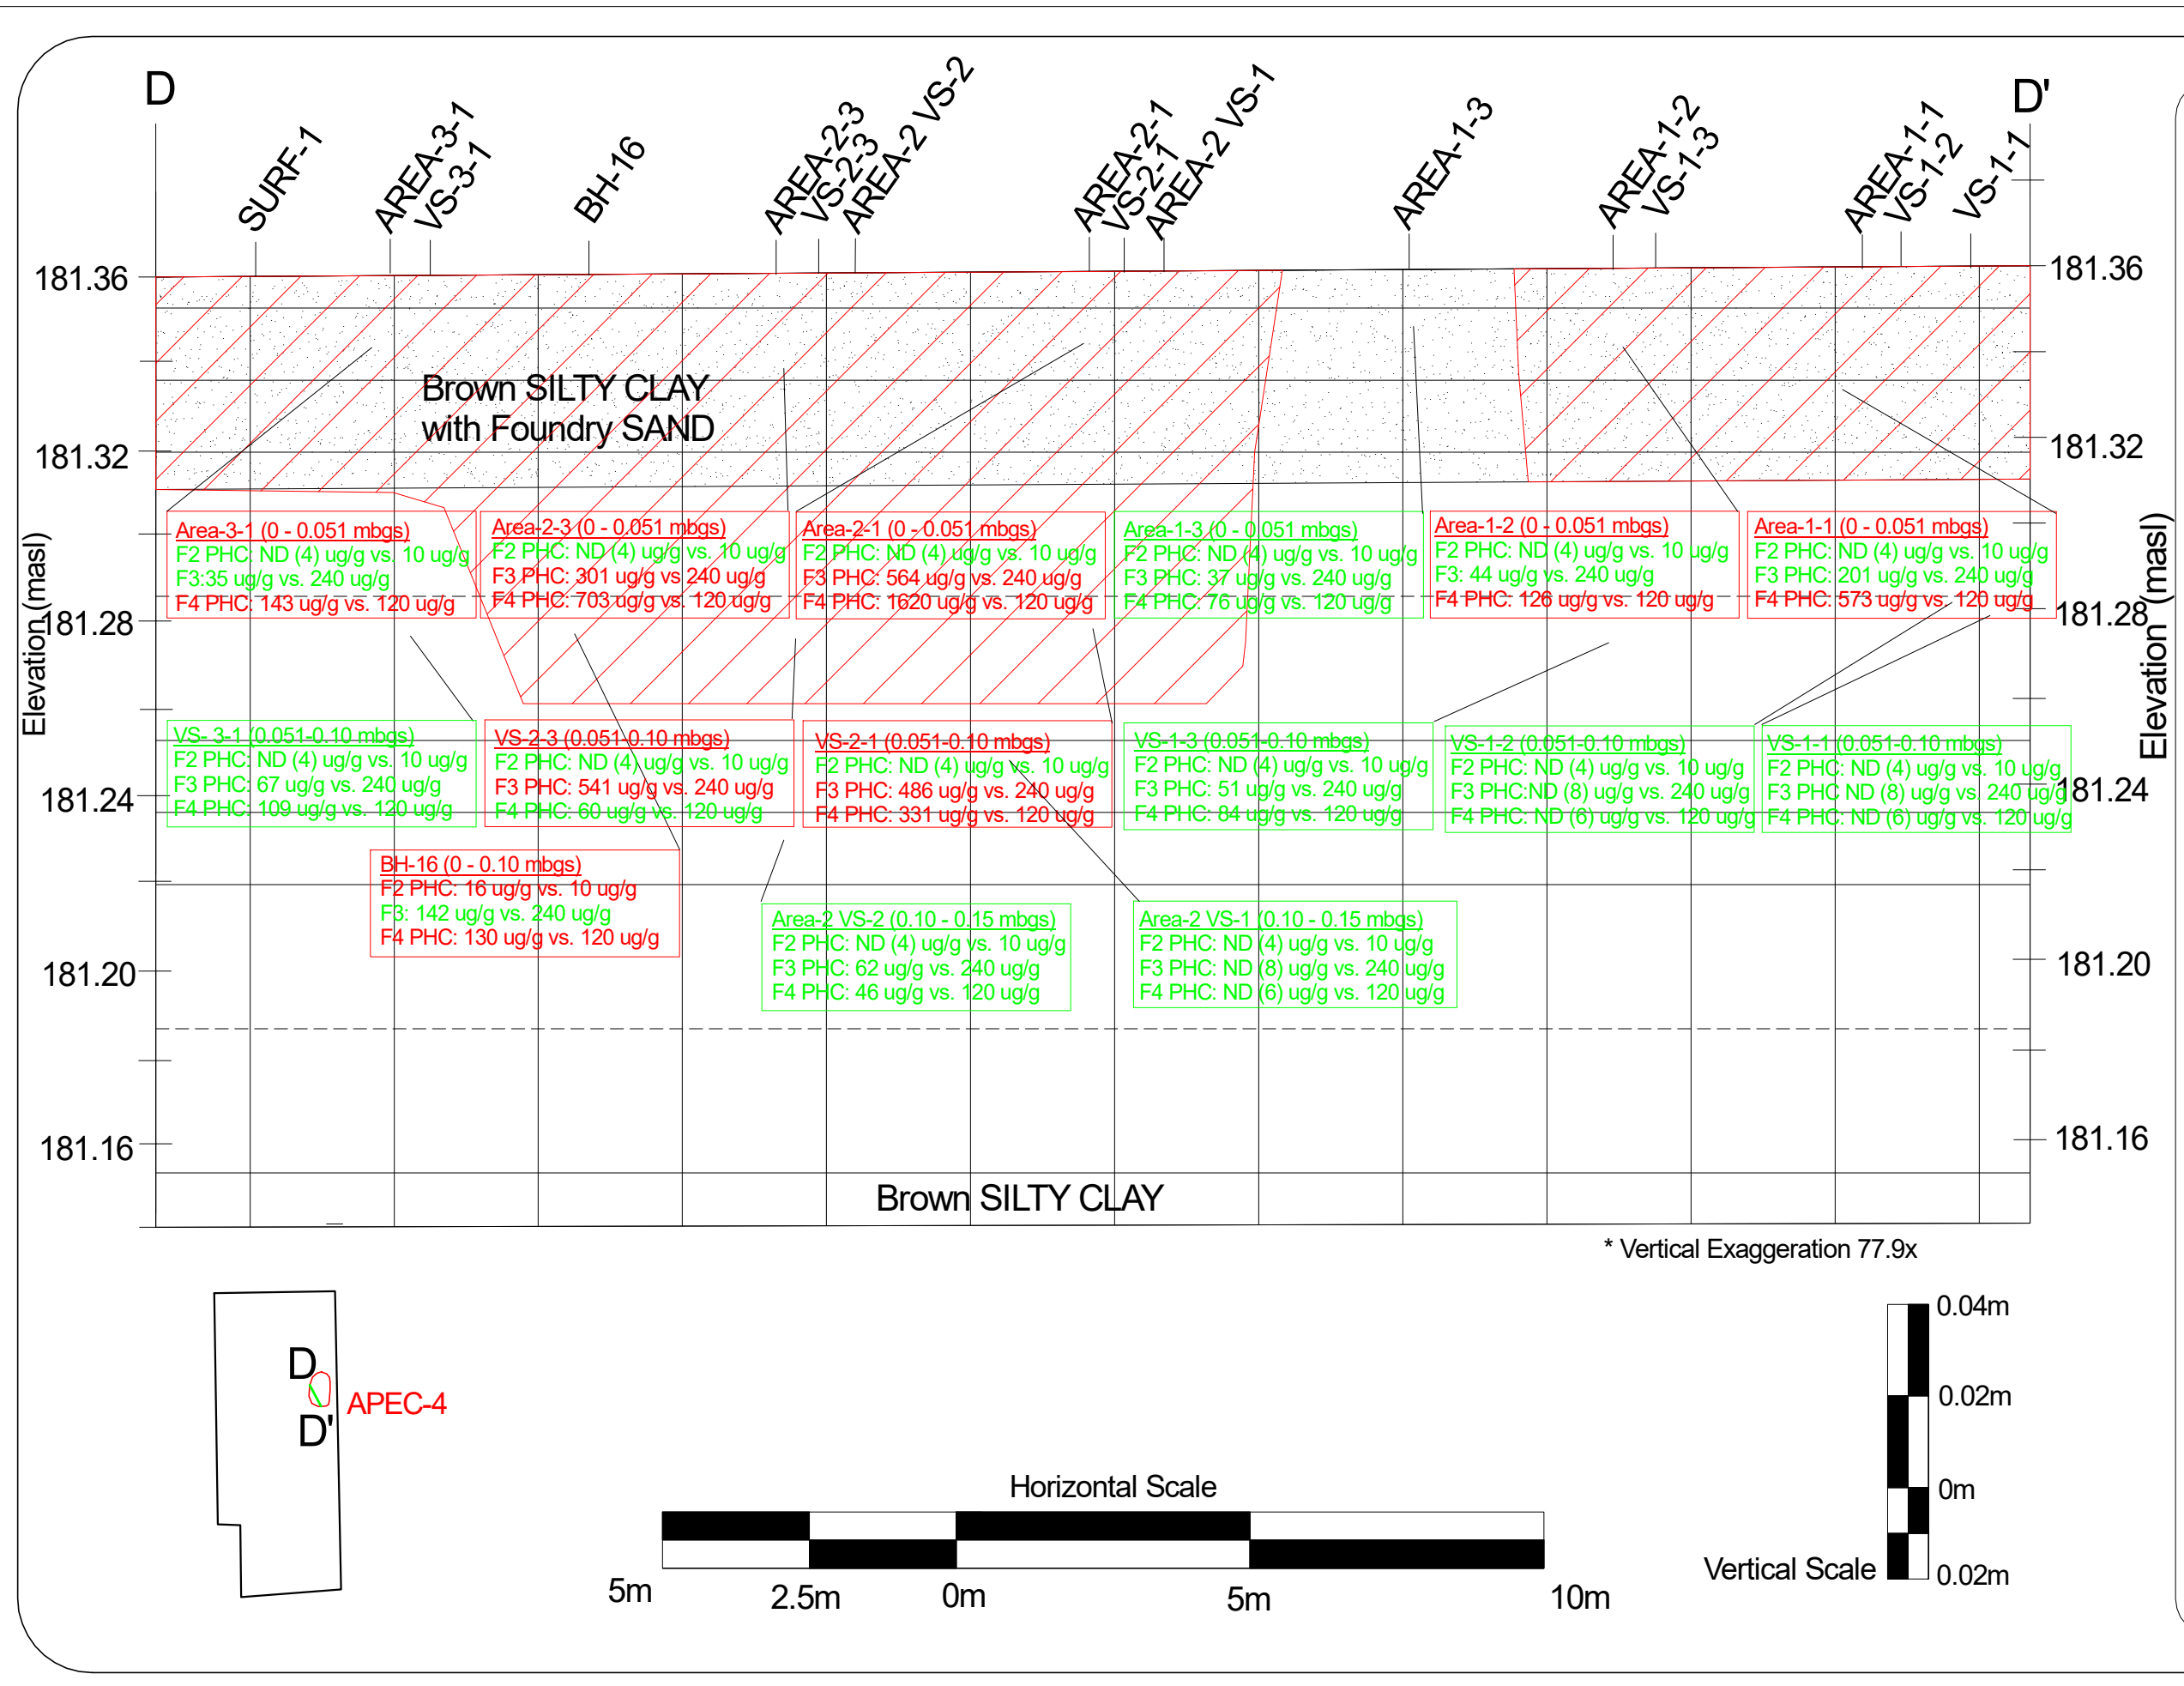
| <b>DATE:</b><br>November 2017 | <b>7b</b> |

\* Vertical Exaggeration 149.14x

Subsequent removal of material within Area 2 to final floor sampling depth of 6'' (0.15m) followed by final verification sampling and analysis concluded that the requirements of Ontario Regulation 153/04, amended by O.Reg. 511/09 Table 9: Generic Site Condition Standards for Use within 30 m of a Water Body in a
